Acidic Drink Corrosion

ZIRCONIA SOLUTION

ComposiCoat BP™ Coating System

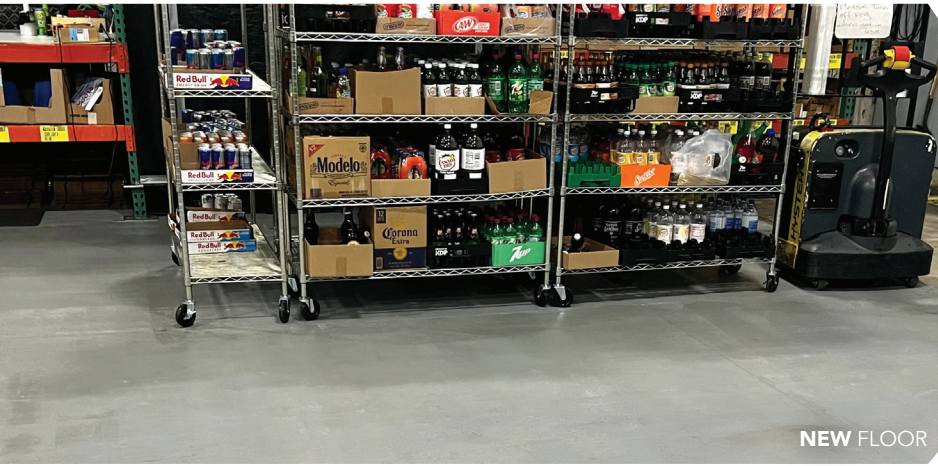
NEW FLOOR

Continuing outcome: After months of regular use, the coating is still completely intact with no signs of wear or delamination. The concrete is free of new contamination and workers have an easy to clean, safe non-slip floor.

To prevent this issue from happening again, Columbia decided to install a protective floor coating over the new concrete. They also wanted a floor that would be easy to clean and provide non-slip characteristics.

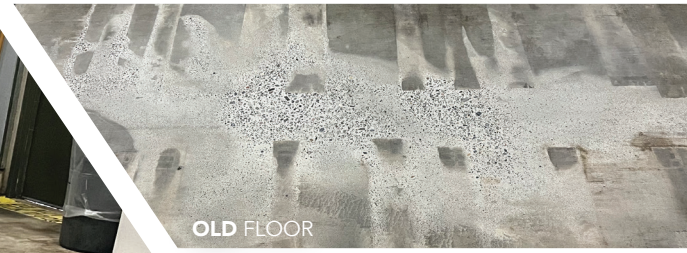
OLD FLOOR

Columbia distribution is a major distributor of alcoholic and non-alcoholic beverages, and when these liquids come in contact with concrete they eat away at the surface. They were forced to replace the concrete surrounding a product disposal area due to the slab being severely deteriorated.

Many beverage types, such as sodas and juices, can quickly eat away and chemically destabilize concrete. In this facility damaged product is stored in a staging area before disposal, but these items often leak and eat away at the concrete. As a result, this floor was continually exposed to food acids, sugars, and other contaminants that ate away the concrete. Additionally, this created ideal conditions for microbial growth which caused further corrosion. The previous surface treatment was not suitable for these exposure conditions, which led to complete concrete failure and necessitated replacing the slab.

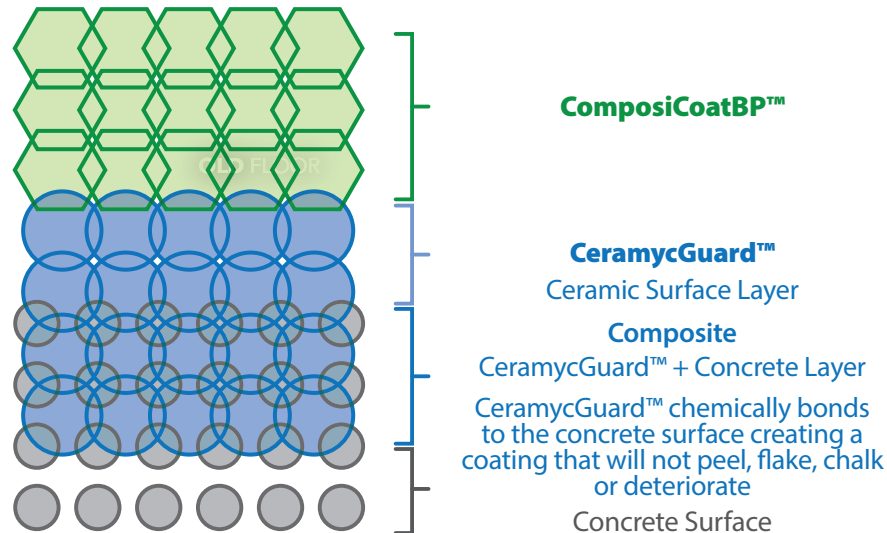
How it Works:

All TruComposite™ systems start with CeramycGuard™, a Ceramic Surface Treatment that uses alumina and zirconia silicates to renew and preserve concrete surfaces. This dense nano-ceramic polymer penetrates and atomically bonds to all available elements in the concrete, shielding the surface from the environment. CeramycGuard™ is not affected by wet/dry or freeze/thaw cycles, and will not peel, flake, chalk, or delaminate in any manner. CompositCoat BP™ is a finish coat which is applied directly over the CeramycGuard™ base layer and chemically crosslinks to form an incredibly dense final coat with superior chemical resistance and exceptional physical wear resistance. Working together with CeramycGuard™, CompositCoat BP™ creates a TruComposite™ coating system that is chemically bonded to the concrete. This means it cannot disbond or fail like traditional organic coatings like epoxies and urethanes alone.

The CompositCoat BP™ system chemically transforms porous, hard-to-clean concrete surfaces into a dense, organic-ceramic composite surface with these additional attributes:
